Title of Final Project: HISTORIC STRUCTURE INVESTIGATION:
THE GOSHEN FARM HOUSE, CAPE ST.
CLAIRE, MARYLAND

HISTORIC STRUCTURE INVESTIGATION: THE GOSHEN FARM HOUSE,
CAPE ST. CLAIRE, MARYLAND

Final Project submitted to the Faculty of the Graduate School of the
University of Maryland, College Park, in partial fulfillment
of the requirements for the degree of
Master of Historic
Preservation
2022

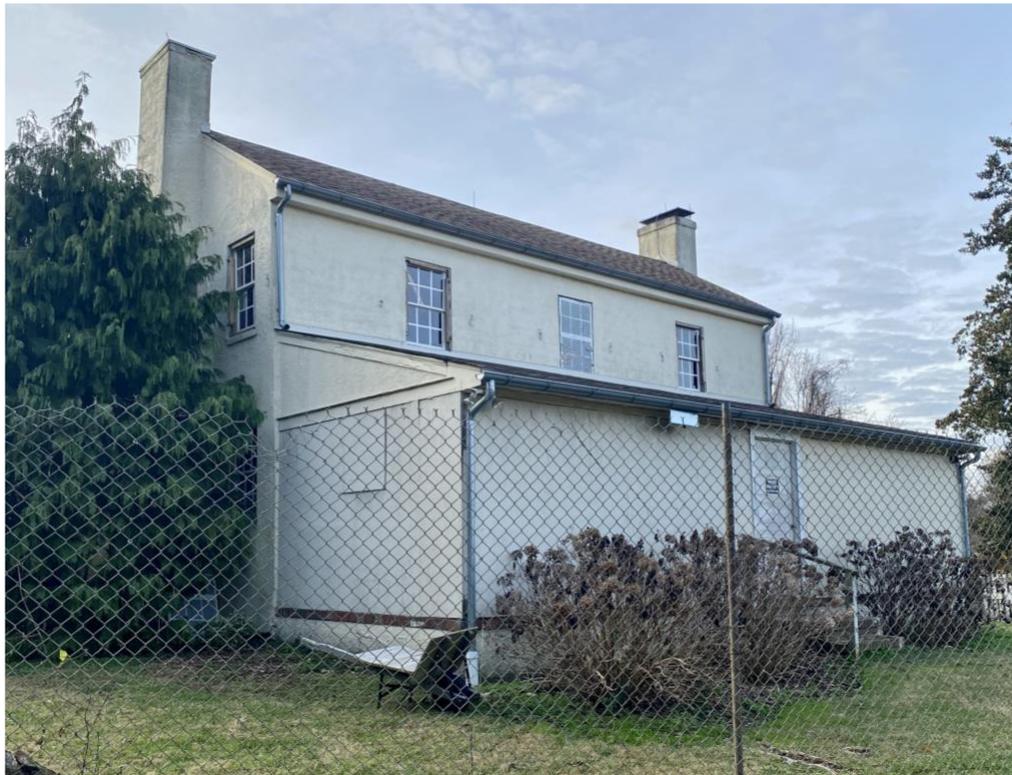
Figure 1. Goshen Farm House façade, viewed from southeast (*Grant Cunningham, 2022*).

The Goshen Farm House was constructed as a three-bay, single-pile, two-story building, traditionally timber framed and arranged in a central passage, hall-and-parlor configuration. This first iteration of the house was informed by the design aesthetic and construction logic of the Federal period, and there remain some decorative elements from this era, including Rumford-style fireplaces and a reverse ogee mantel. The Phase II building, which was attached to the rear of the main residence in the late nineteenth century, was built as a two-story, single-pile structure in a one-up and one-down configuration typical of farmstead service buildings. Its framing members are notably different from their Phase I counterparts in that they are circular sawn and of smaller dimensions. The house during these first two periods likely was sheathed in exterior wood weatherboard, which was covered by stucco before the two latter phases were undertaken. Phase III construction of a bathroom space required further alterations to the fenestration of the original house, and the Phase IV campaign gave the structure its current form. Together, these phases of the building's chronology document not just the changing nature of the farmhouse, but also broader trends reflecting the region, its inhabitants, and the ways in which they built their homes.

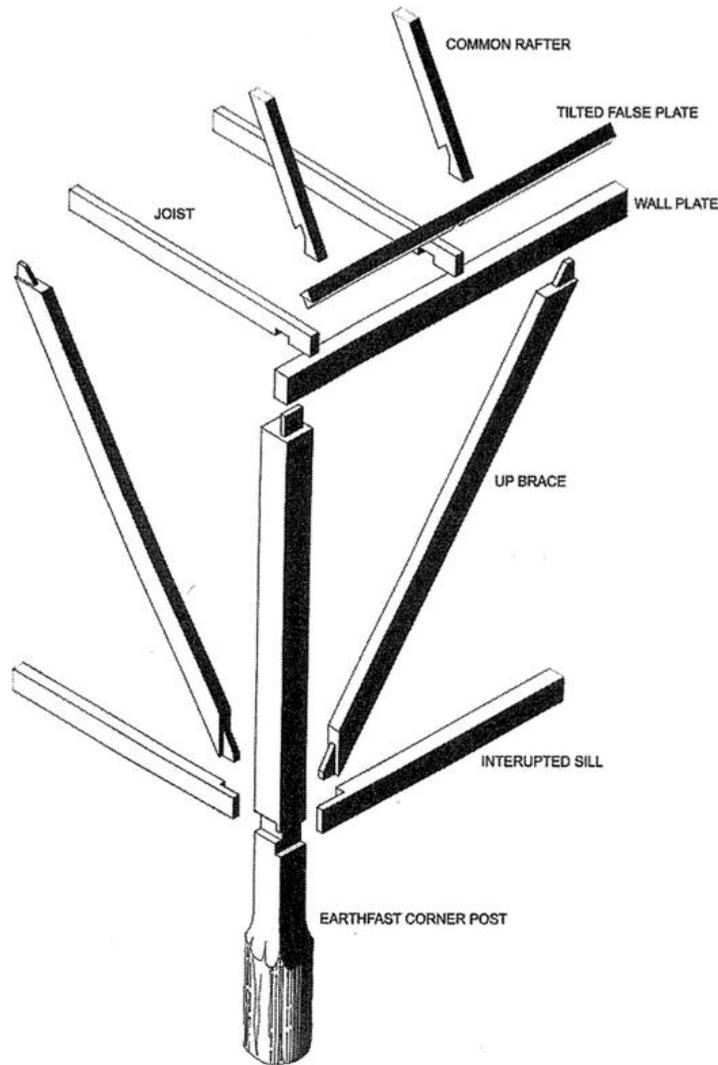
Figure 9. Model of seventeenth-century earthfast construction, Chaney Tobacco Barn, Anne Arundel County (*Graham, “Preindustrial Framing in the Chesapeake,” Perspectives in Vernacular Architecture Vol. 9 (2003), 180.*)

Earthfast design is also known as post-in-ground construction; under this building scheme, the frame of a structure utilized spaced piers or posts set in holes dug in the ground, saving the builder from constructing a full stone or brick foundation.⁵⁴ Post-in-ground construction was utilized across British North America in the early seventeenth century, but remained uniquely prevalent in the Chesapeake region throughout the first half of the colonial period.⁵⁵ The enduring popularity of the technique in the region was further evidence of the unsettled nature of the early colonization effort, which featured high mortality rates from the unfamiliar climate, a lack of settled family units, and a boom mentality driven by colonists convinced that they would shortly return to England with tobacco-related profits.⁵⁶

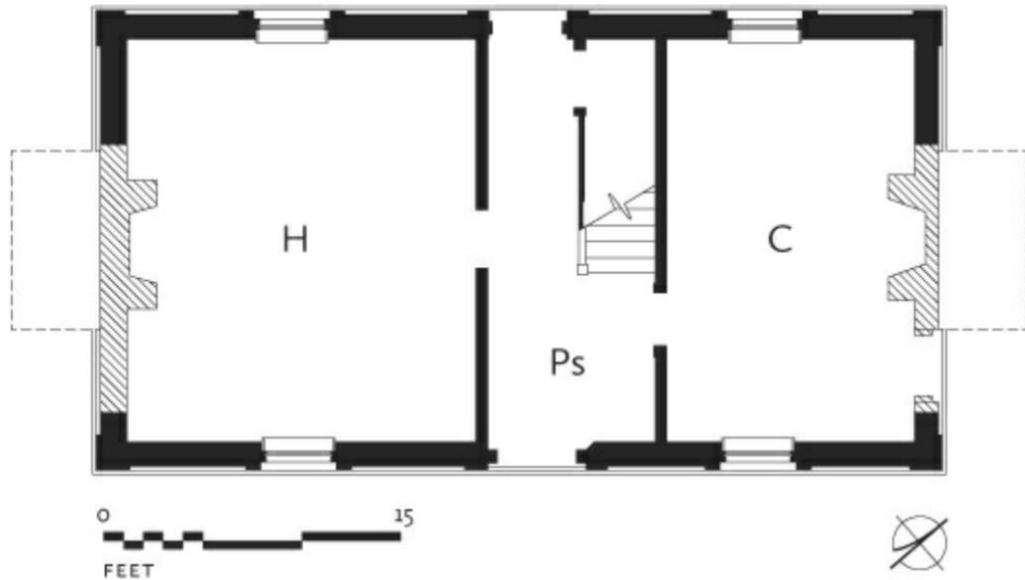
Figure 10. Central passage hall-and-parlor plan example from Accomack County, Virginia (Mark R. Wenger, “Town House & Country House: Eighteenth and Early Nineteenth Centuries,” in *The Chesapeake House*, 125).

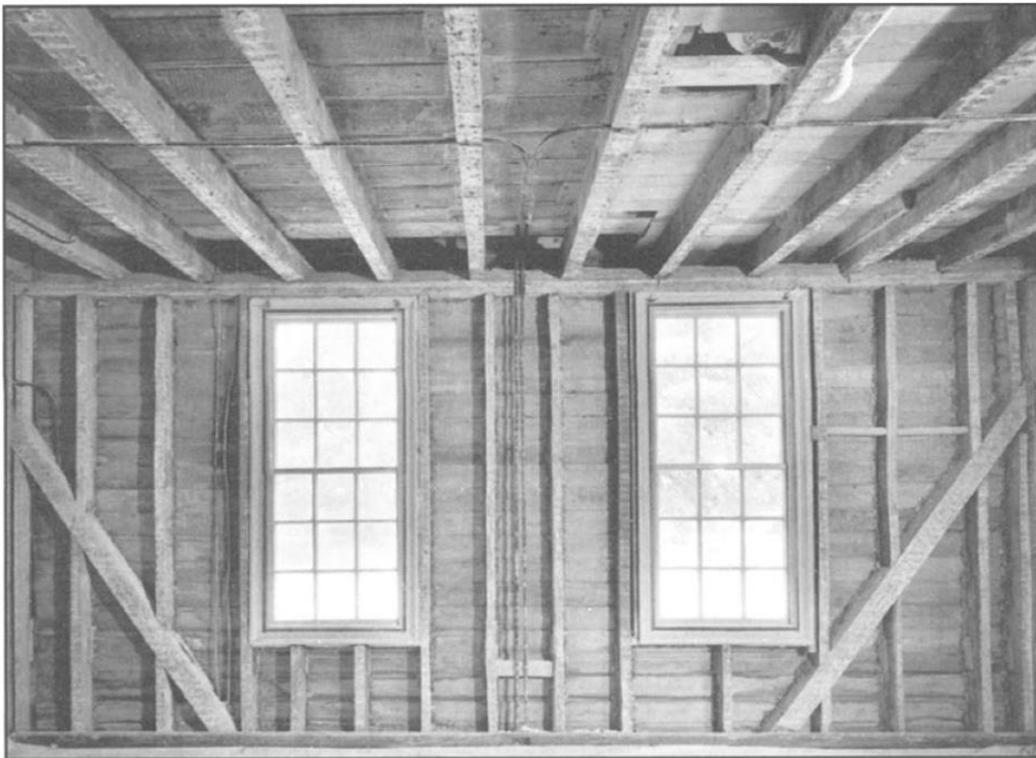
Figure 11. John Blair House, Williamsburg, Virginia, showing flush framing of all wall members, 1722 (*Graham, “Preindustrial Framing in the Chesapeake,” 190*).

without compromising the stability of the house, and ultimately a standard “flush framing” system was developed.⁷⁸ Under the new scheme, those elements were all sawn to roughly 4-5 inches so that they could be easily covered by plaster and lath. This reform was also effected in light of decreasing labor costs associated with widespread chattel slavery, making the refinement of heavy structural elements via pit saw a practical endeavor.

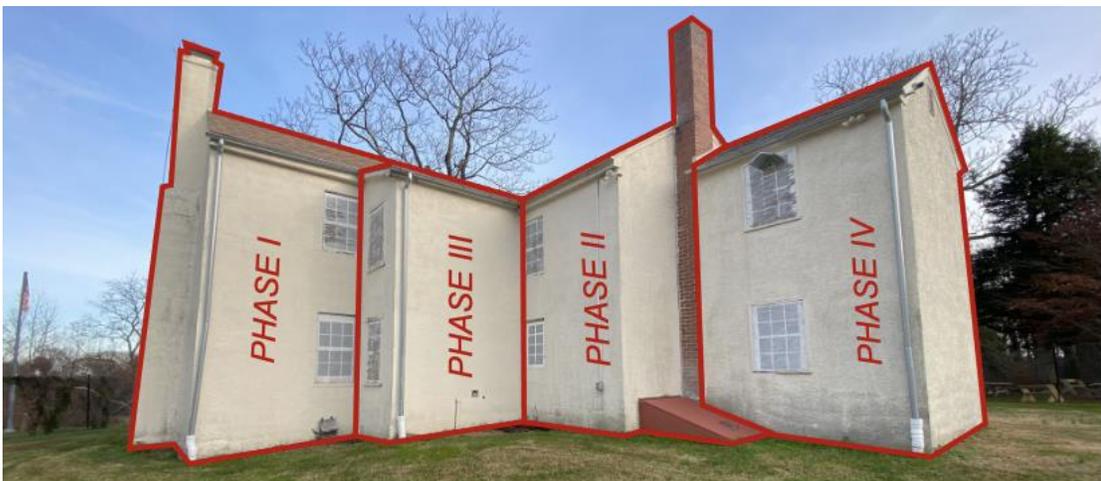
Figure 12. Goshen Farm House, viewed from northwest, showing all four construction phases (*Grant Cunningham, 2022*).

The Goshen Farm House was constructed in four phases between the late eighteenth century and 1967, spanning approximately 187 years of occupation and development on the property. The first and most substantial portion of the farmhouse was constructed between 1780 and 1798 as a two-story, central passage hall-and-parlor house finished with Federal-style details, though subsequent additions have altered many original features. The second building campaign joined a two-story service building as an ell to the rear of the original house around the turn of the twentieth century. Various elements visible in the structure's framing suggest that it was originally constructed closer to the middle of the nineteenth century and later moved and attached to the main block. A third expansion was carried out in 1935, adding a two-story bathroom section, while a fourth expansion added another two-story addition to the rear of the ell in 1967.

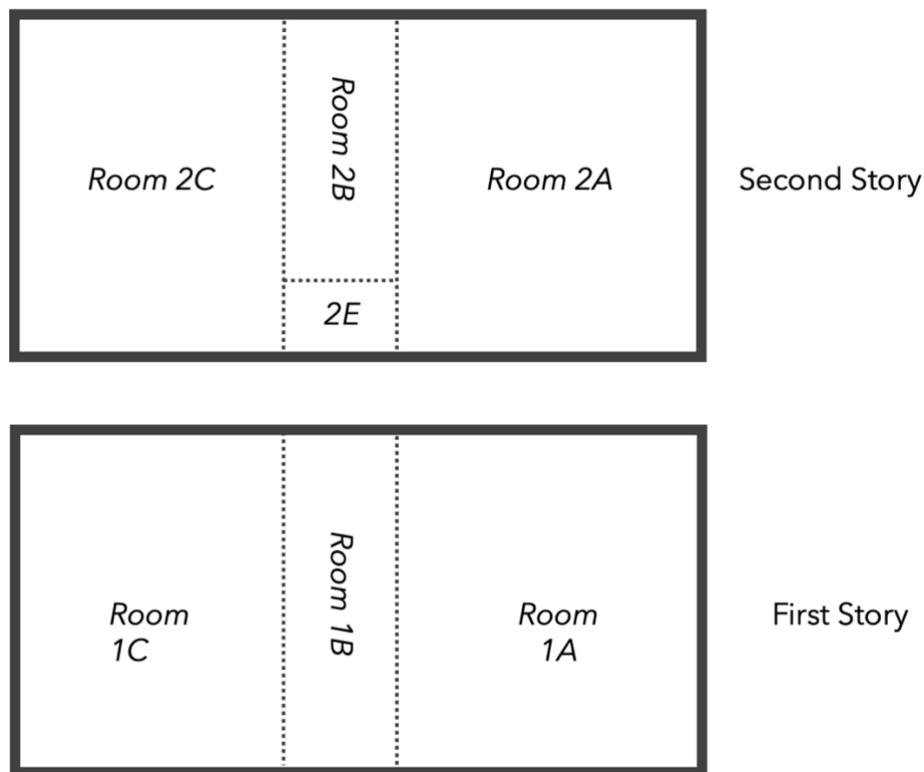
Figure 13. Phase I central passage, hall-and-parlor plan (*Grant Cunningham, 2022*).

The Phase I house is a three-bay, single-pile, two-story residence, constructed according to a central passage hall-and-parlor plan atop a local, uncoursed, ironstone foundation and features a side-gabled roof. The exterior of the building was likely clad in weatherboard siding nailed to the vertical framing members, while the roof would most likely have been covered in wood shingles. The current weatherboard siding on the Phase I house is circular sawn and likely dates to the mid-nineteenth century, while the roof shingles are not historic (Figure 14). The house's façade faces east (northeast) and originally featured a single doorway at the center of the first story flanked on either side by a single, six-over-six, sash window. The second story of the east façade featured three, evenly spaced, six-over-six, sash windows positioned over the first story openings. During Phase I, the north and south side elevations had no window openings on either story; a brick, exterior end chimney was centered on each wall. The first story of the rear elevation likely featured the same arrangement of doors and windows as the east or front façade, with a centered, rear door and a window on either side. On the second story, three evenly spaced, six-over-six, sash windows would have similarly mimicked the arrangement on the façade.

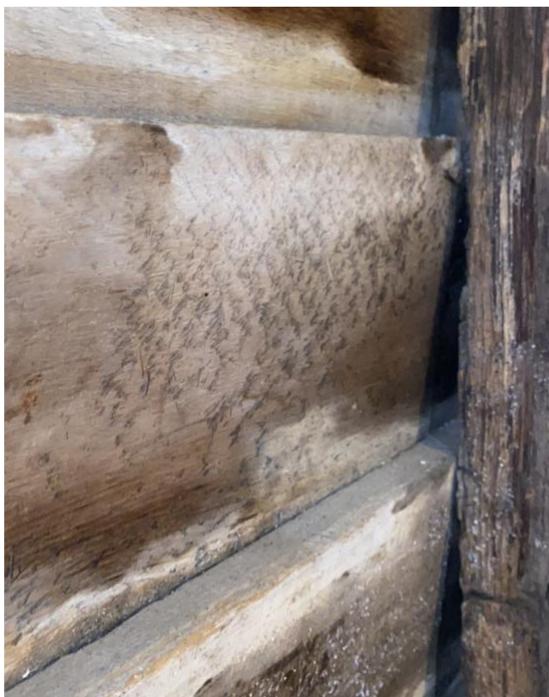
Figure 14. Circular sawn weatherboard siding in Phase I house (*Grant Cunningham, 2022*).

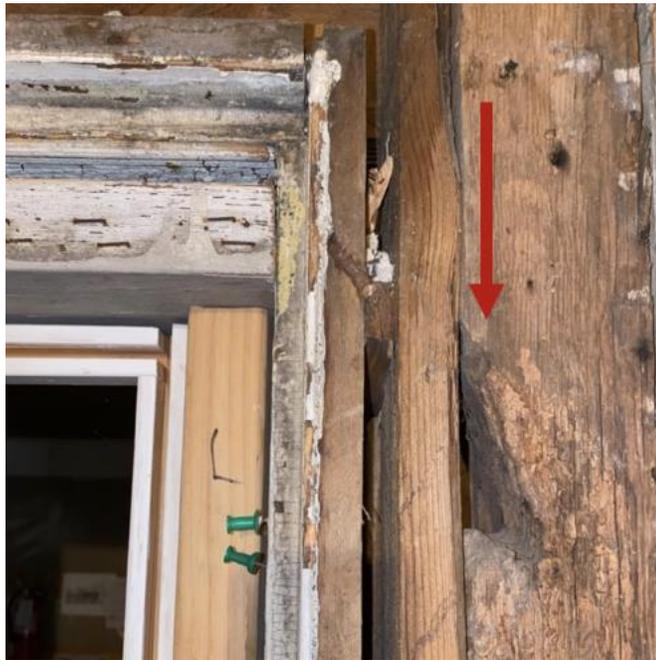
Figure 16. Notching for original entry door header, central passage (*Grant Cunningham, 2022*).

passage as well; an exterior doorway at the passage's west wall is set just north of the staircase, and while its dimensions are slightly smaller than the other three original doorways on the first story, the door frame does not interrupt the wall framing members and is likely an original entryway, later altered.

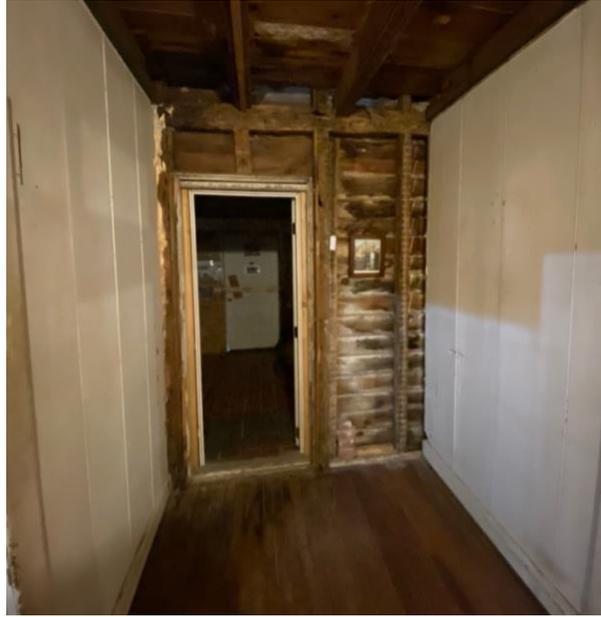
Figure 17. Center passage partition walls on either side of the front entrance to Phase I (*Grant Cunningham, 2022*).

The central passage is framed by interior partition walls at the north and south ends. These walls are composed of broad, beaded boards of irregular width and are almost certainly original to the construction of the Phase I house (Figure 17).

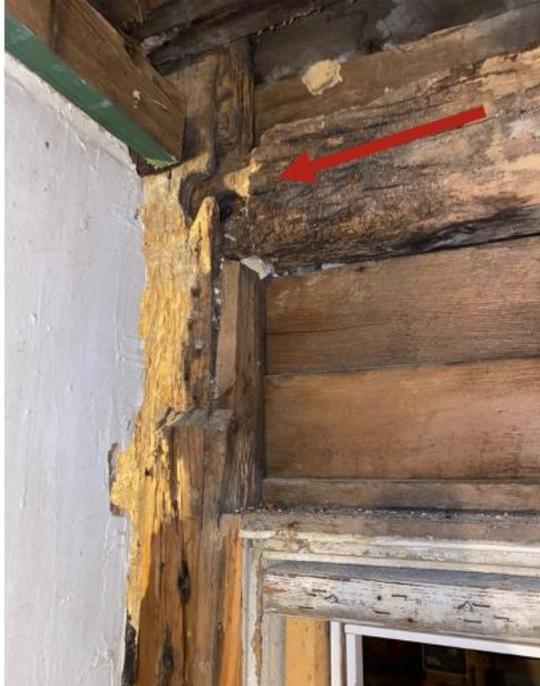
Figure 18. Overlapping notching near central passage partition wall (*Grant Cunningham, 2022*).

Notches in overlapping wall framing members, including a post, are visible where the north partition wall once met the plastered exterior walls and may indicate a location where the partition walls were secured to the exterior structural members (Figure 18). The winder staircase in the central passage is likely original as well, as it was constructed against the first-story south partition wall with no banister on that side and features T-headed, wrought nails securing the cap on each of the newel posts (Figure 19). A small closet with three rows of shelves, also secured with wrought nails, is set under the staircase and likely dates from the same period.

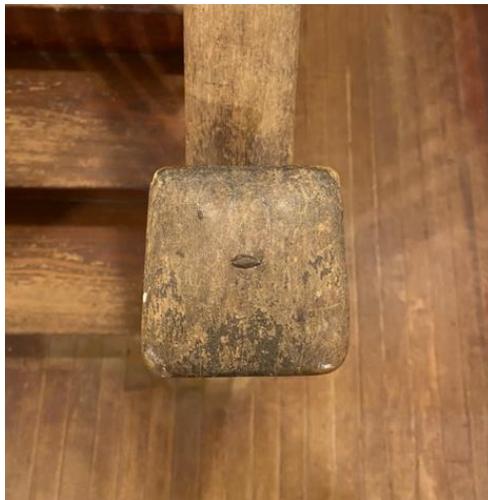
Figure 19. T-head wrought nails in central passage staircase newel post (*Grant Cunningham, 2022*).

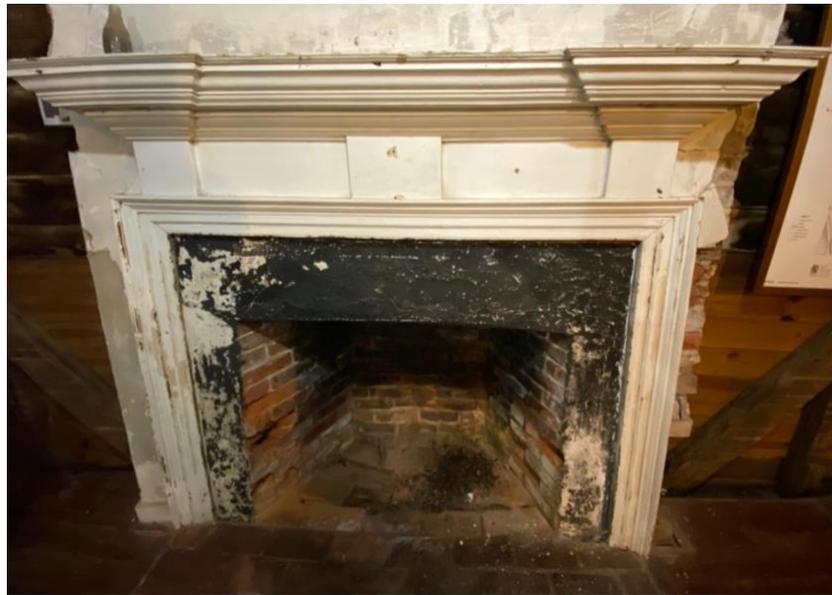
Figure 20. Federal period mantel in Room 1A, north elevation (*Grant Cunningham, 2020*).

It is most probable that the north room on the first floor (Room 1A) functioned as the hall. While both first-story rooms feature reworked Rumford-style fireplaces, the beaded Federal period mantel surrounding the firebox in the north room is more ornate than its counterpart in the south room (Room 1C), indicating a more public-facing use for the former space (Figure 20). The interior doorways between the hall, parlor, and central passage feature beaded door surrounds; a transom light above the door to Room 1C, cut into the partition wall, is an addition from a later period. The interior partition walls have board-and-batten doors with wrought HL hinges and handmade screws; these doors are also original to Phase I (Figure 21).

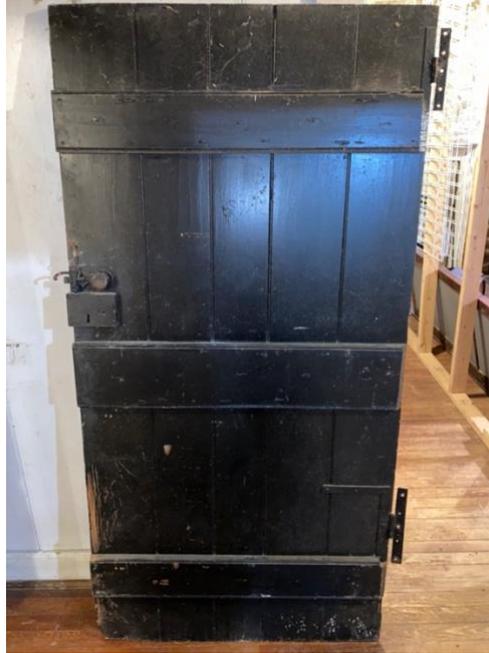
Figure 21. Board-and batten-door separating Room 1A and Room 1B (hall and central passage) featuring HL hinges and handmade screws (*Grant Cunningham, 2020*).

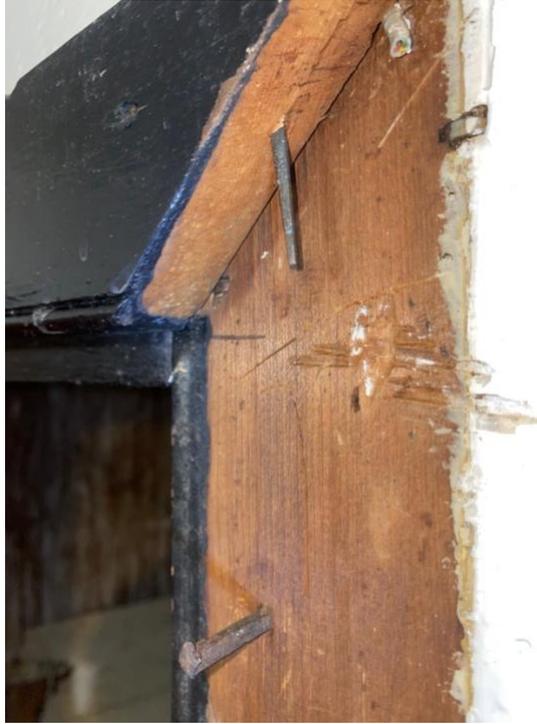
Figure 22. Machine-cut nails, door surround, Room 2D (*Grant Cunningham, 2022*).

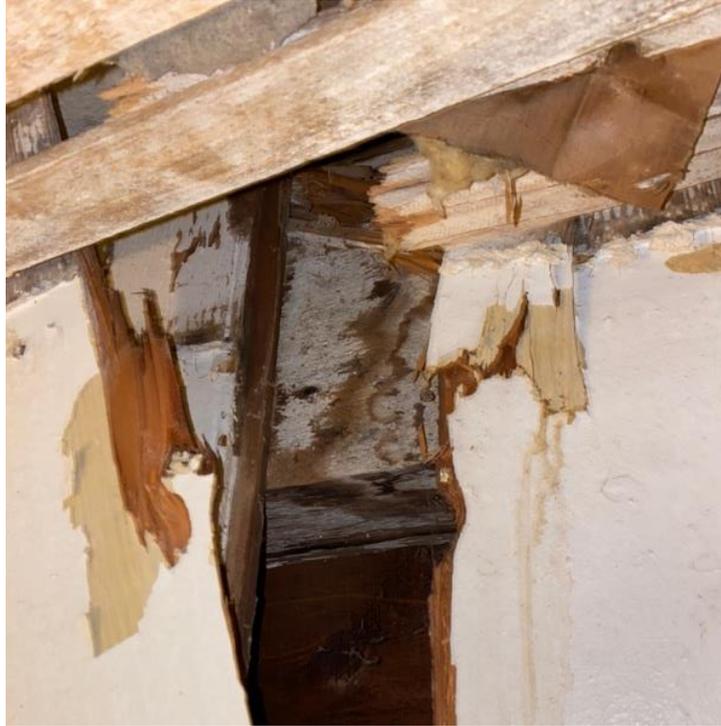
Figure 23. Whitewashed framing member visible under wall paneling (*Grant Cunningham, 2022*).

The framing of the house was treated in various ways throughout the Phase I rooms. Members on the lower floor are not whitewashed, and given the flush framing of the building, it is almost certain that they were plastered during the initial construction of the home; many structural elements on the first floor retain plastering ghost marks from this undertaking. Rooms 2B and 2C on the second story remain partially plastered, while Rooms 2A and 2E are clad in beaded vertical boards of the same kind as the partition walls. The framing on the second story was likely left exposed in its original form, as members visible behind the wall boards in Room 2A exhibit remnants of whitewash (Figure 23). Exposed lath on the second story is circular sawn and fastened to the frame with cut nails. This evidence, along with mid-nineteenth-century butt hinges on the closet doors in Room 2A, indicate that the plastering and paneling of the second story, and therefore the partition of Room 2E from Room 2B, most likely took place around 1850 (Figure 24). This project was likely undertaken at the same time that the attic staircase was inserted, and given the concurrent construction timeframe of the Phase II building, may have been part of a larger renovation and expansion project at the property. The framing in the attic was left exposed and was not whitewashed.

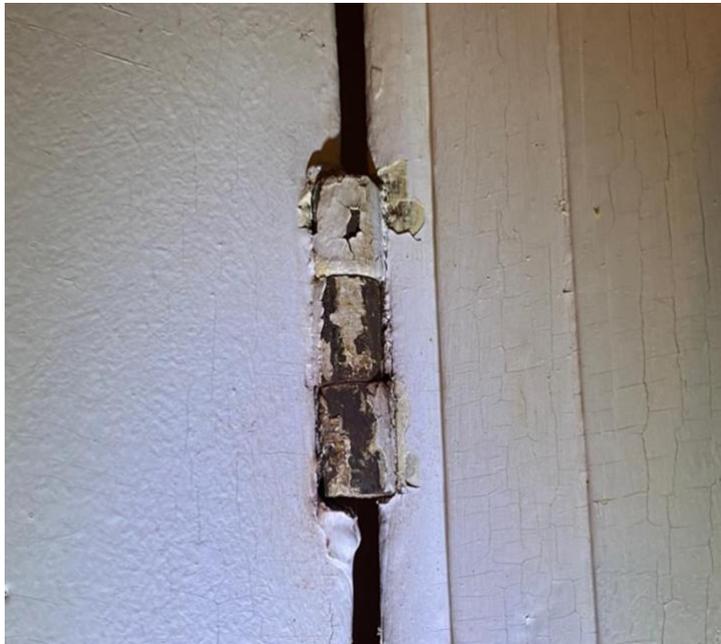
Figure 24. Mid-nineteenth century butt hinge on closet door in Room 2A (*Grant Cunningham, 2022*).

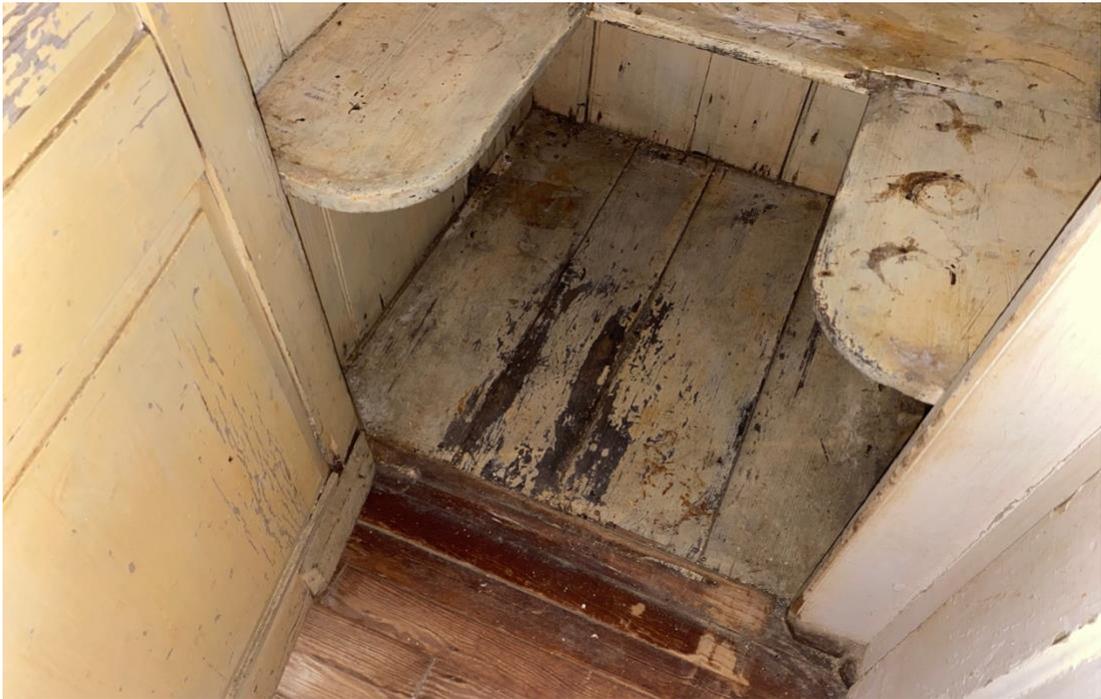
Figure 25. Original Phase I floorboards in staircase closet in Room 1B, newer floorboards at bottom (*Grant Cunningham, 2022*).

The base layer of flooring throughout the Phase I house is tongue and groove, gauged and undercut, and remains intact. This layer is composed of variable width, wood floorboards that run north to south, and is very likely original to Phase I construction (Figure 25). A newer layer of flooring composed of narrower wood floorboards now conceals the base layer across most of the first story, while the second-story floorboards, identical to the original first-story ones, remain uncovered. A simple, beaded baseboard runs the perimeter of Room 1B, but has otherwise been removed from the first story along with the plastered walls—though ghost marks on the partition walls indicate its past presence. The second story features a beaded baseboard in all rooms, save Room 2C, where it has been partially replaced by a later, simpler baseboard near the area later joined to the Phase Two structure (Figure 26).

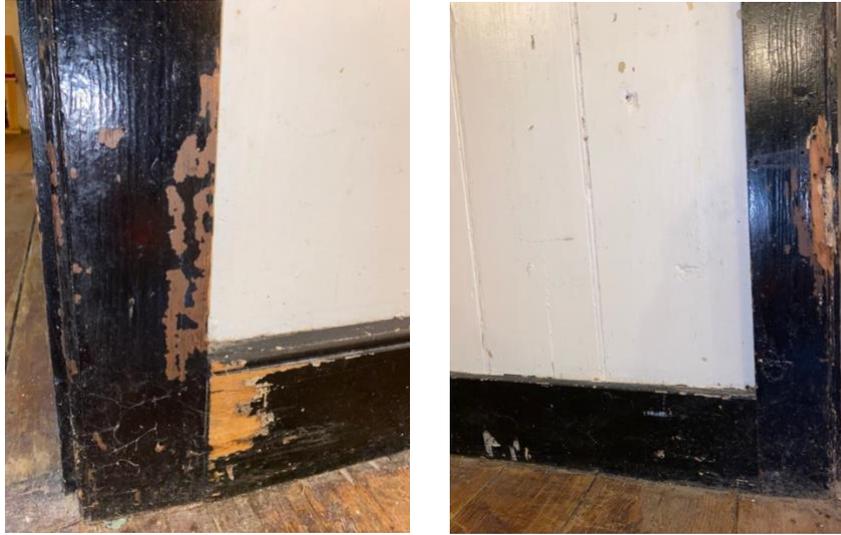
Figure 26. Original beaded baseboard (left) and replacement baseboard (right) in Room 2C (*Grant Cunningham, 2022*).

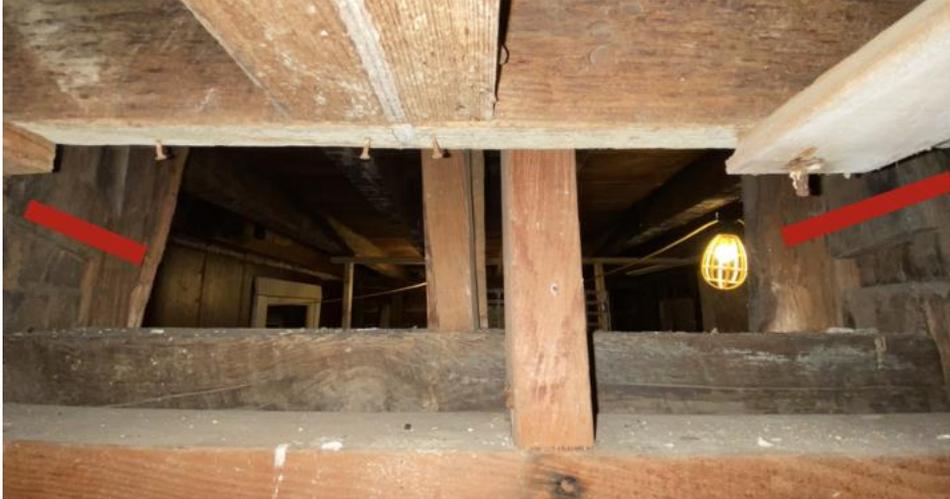
Figure 27. Notching for window header above doorway from Room 1C to Room 1D (Grant Cunningham, 2022).

Changes to the fenestration of the Phase I house, particularly in Rooms 1C and 2C, are evident from modifications to the framing. In Room 1C, both corner downbraces on the south end wall have been severed to make way for later windows on either side of the fireplace opening, while the joining of the Phase II ell at the rear changed the room's west-facing window into a doorway; notches in the framing for the window header are still present at the same height as the other first-story original windows (Figure 27; Appendix C). The west-facing window in Room 2C was likewise changed into a doorway to accommodate the Phase II addition, while a south-facing window in the same room was added later as well, mimicking the changes on the first floor.

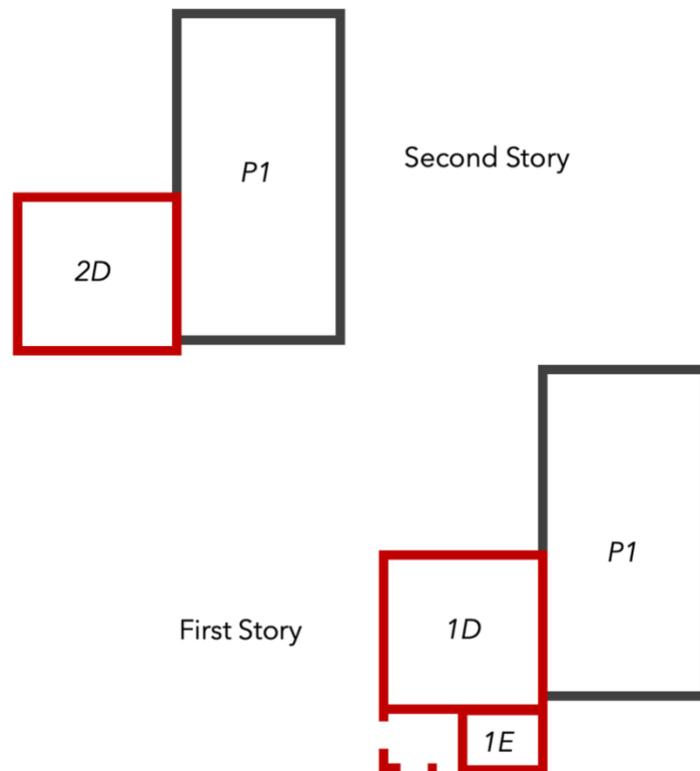
Figure 28. Phase II house plan with attached rear ell (Grant Cunningham, 2022).

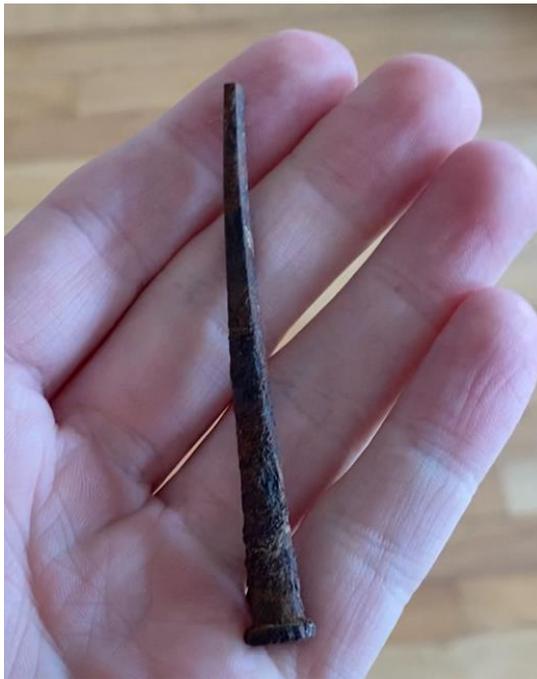
Figure 29. Mid-nineteenth-century cut nail removed from rafter in Phase II attic (*Grant Cunningham, 2022*).

The second construction campaign joined a pre-existing building to the rear of the Phase I house as an ell addition sometime between 1890 and 1910. This building's origin is unclear but it was likely moved from a different location on the same property. It seems likely that the structure was built ca. 1850-1860, perhaps when Henry Tydings began renting the property in 1850 or when he purchased it in 1853. Nails used in the rafter construction of the ell addition are iron, machine-cut and headed, with rectangular shafts, flat points, and burrs on one side, corresponding to Nail Type 8b in *Historic Louisiana Nails*.⁹² This nail type has a documented history of use nationally from ca. 1830 to 1885, placing the construction of the building, later attached as an ell addition, within these dates (see Figure 29).

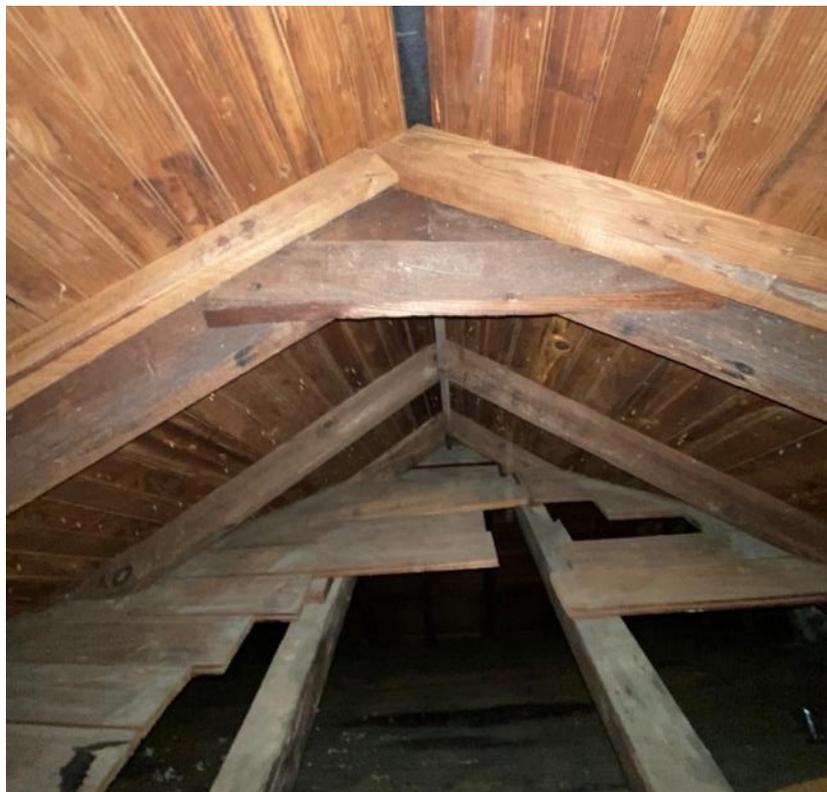
Figure 30. Original Phase II rafters joined without ridge board, foreground; later rafters joined at ridge board in Phase II roof extension, background; Phase One roof in far back (*Grant Cunningham, 2022*).

attest to the move. The roof must have been extended at the time of the attachment to meet the Phase I gable, as it could not have functioned without an extension linking it to the earlier building. Material discrepancies between the addition's original roof and the extension provide evidence that the move was made several decades after the building's ca. 1850-1860 construction. Specifically, the presence of a ridge board and wire nails to attach members confirms the use of later construction technologies unavailable in the mid-nineteenth century (Figure 30). Both elements became common features of house construction in the latter nineteenth century, though the use of wire nails in the Chesapeake region can be more reliably assigned to ca. 1890 or later.

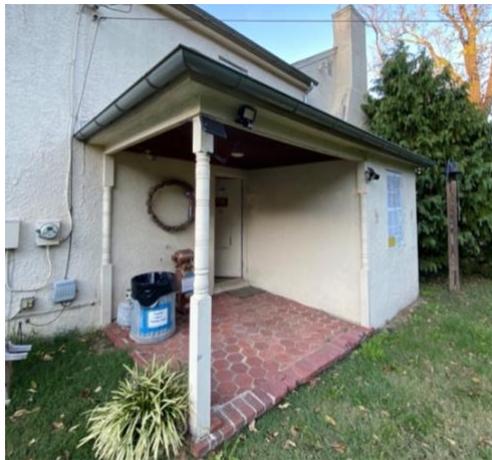
Figure 31. South façade of Phase II ell addition; covered porch at left, Room 1E at right, both under hipped roof (*Grant Cunningham, 2022*).

The covered porch on the building's south side is very likely original to the construction of the Phase II building, as the framing of the hipped roof which covers it is circular sawn and uninterrupted (Figure 31). One corner post from this porch, a whitewashed timber left in the round, is kept onsite and verifiably dated to at least 1917, though it likely predates this year, as various machine-cut nails are embedded in it.⁹⁴ The original supports for the porch have since been removed and the roof now rests on three ornamented posts, added at a later period.

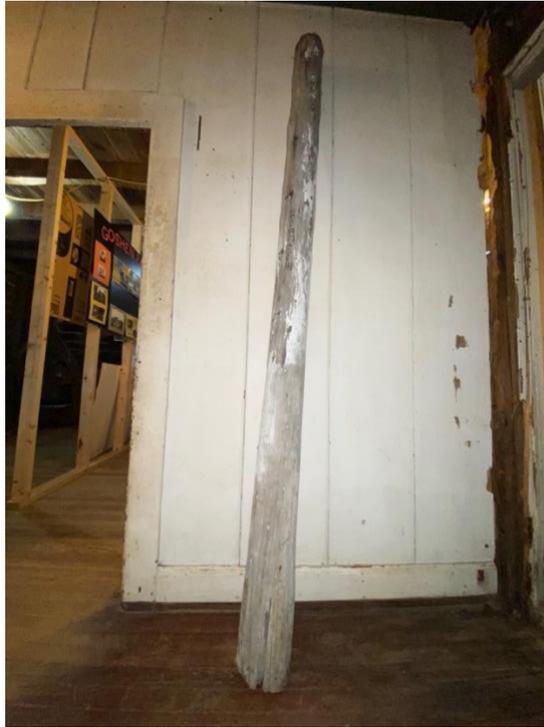
Figure 32. Whitewashed side porch post, left in round and marked “1917” (*Grant Cunningham, 2022*).

⁹⁴ One of the children of resident Mary Ann Brice carved his signature and the year 1917 into the wood post, see Figure 32.

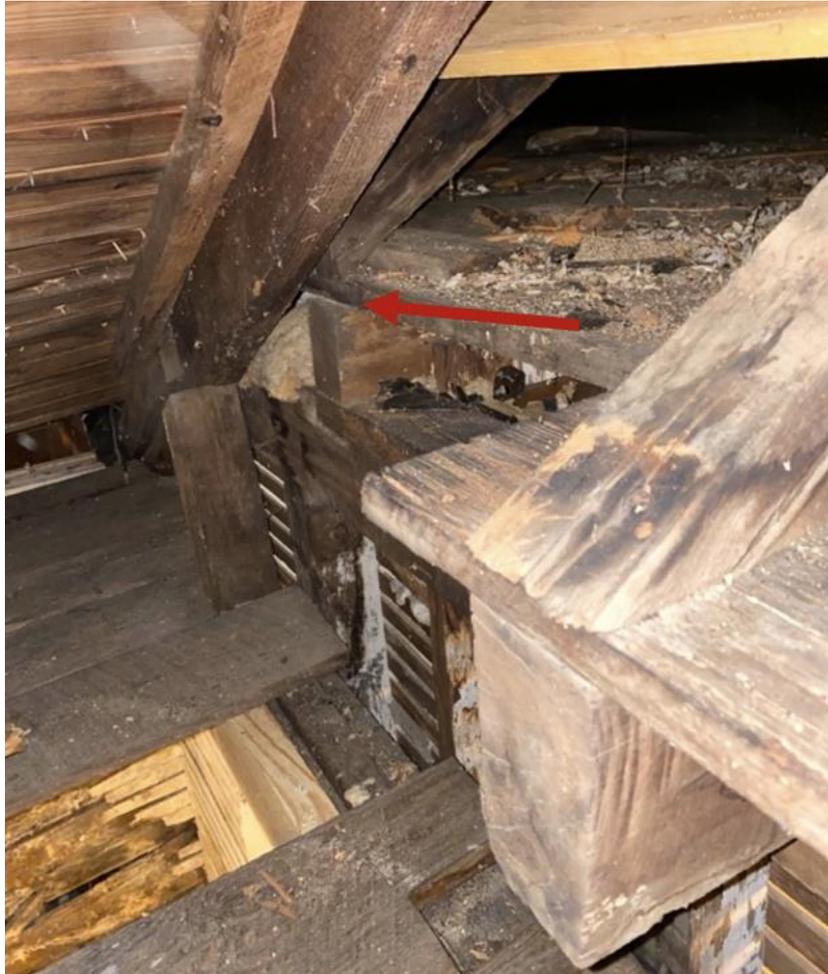
Figure 33. Phase I rafter end cut at joining of Phase II roof (*Grant Cunningham, 2022*).

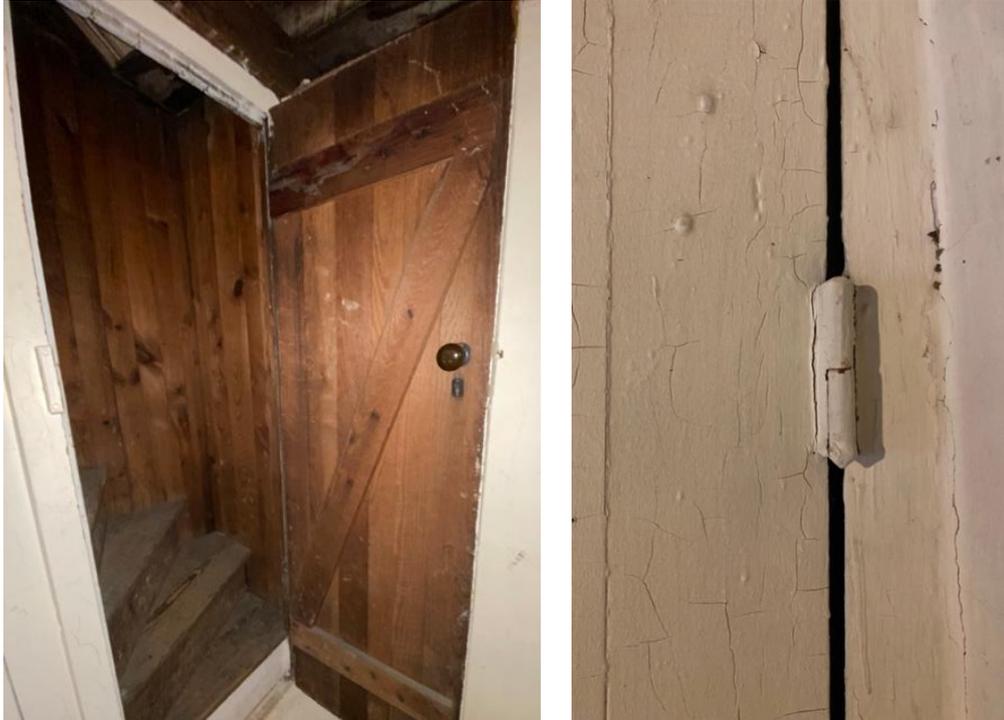
Figure 35. Second-story staircase to attic in Room 2D, featuring a board and batten door at bottom with cut nails (*Grant Cunningham, 2022*).

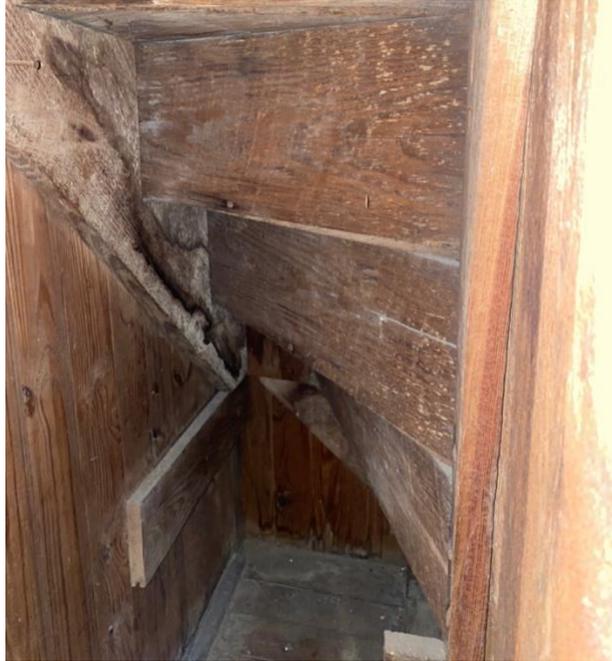
Figure 36. Circular sawn risers and machine-cut nails underneath attic staircase in Room 2D (*Grant Cunningham, 2022*).

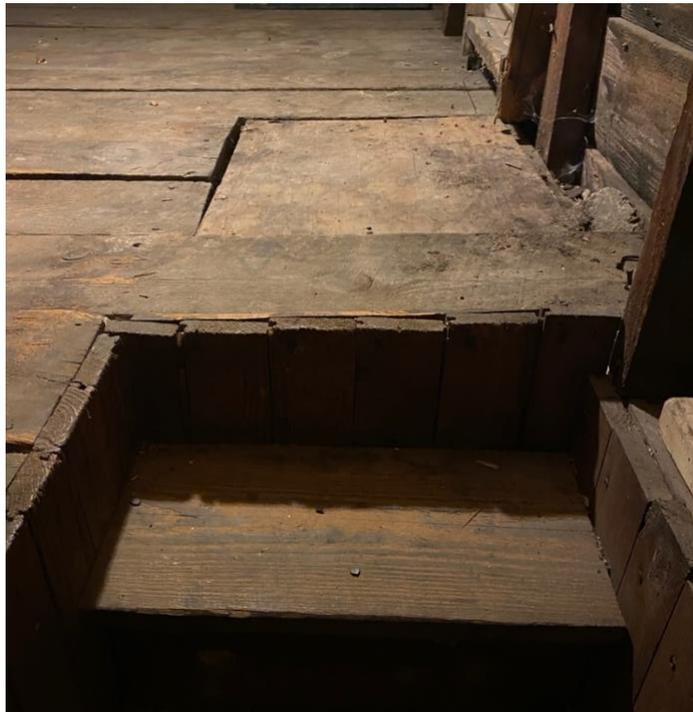
Figure 37. Attic staircase in Room 3B, showing floor patch where interior end chimney was previously located (*Grant Cunningham, 2022*).

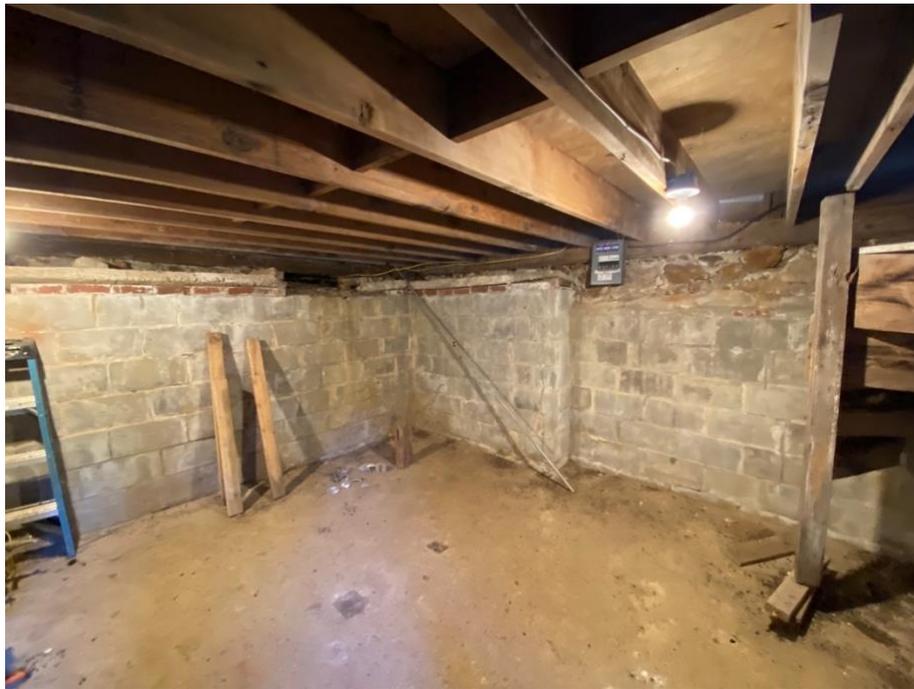
Figure 38. Cellar under Phase II (Room 0D) showing CMU walls, south and east elevations (*Grant Cunningham, 2022*).

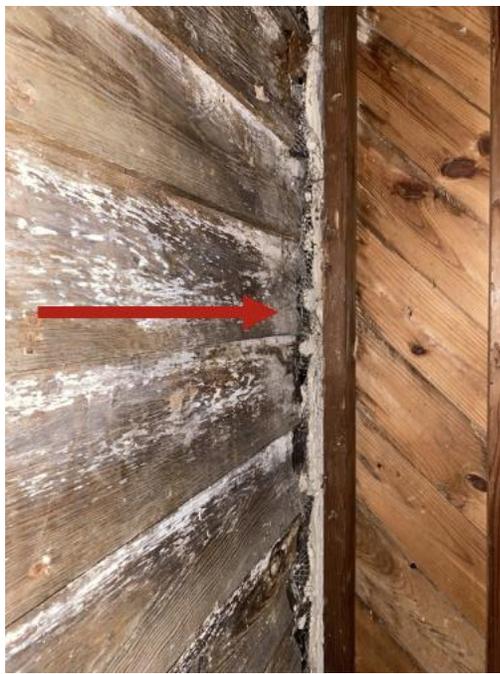
Figure 40. Remnants of stucco on the interior of the Phase III bathroom space, (Grant Cunningham, 2022).

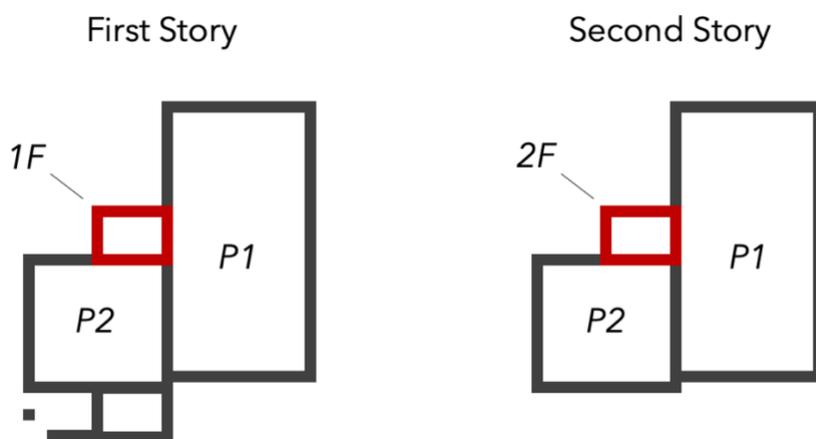
Figure 41. Phase III house plan (Grant Cunningham, 2022)

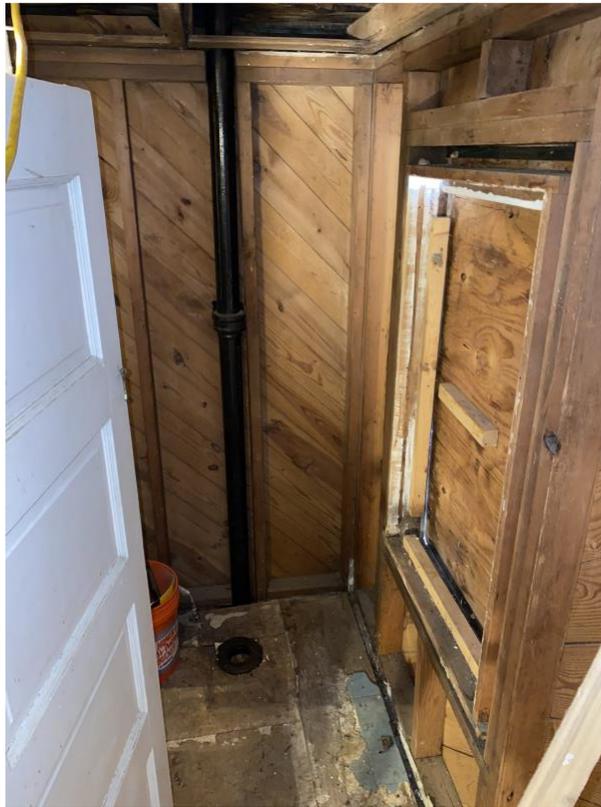
Figure 42. Second-story bathroom addition (Room 2F) built during Phase III, view towards west elevation (*Grant Cunningham, 2022*).

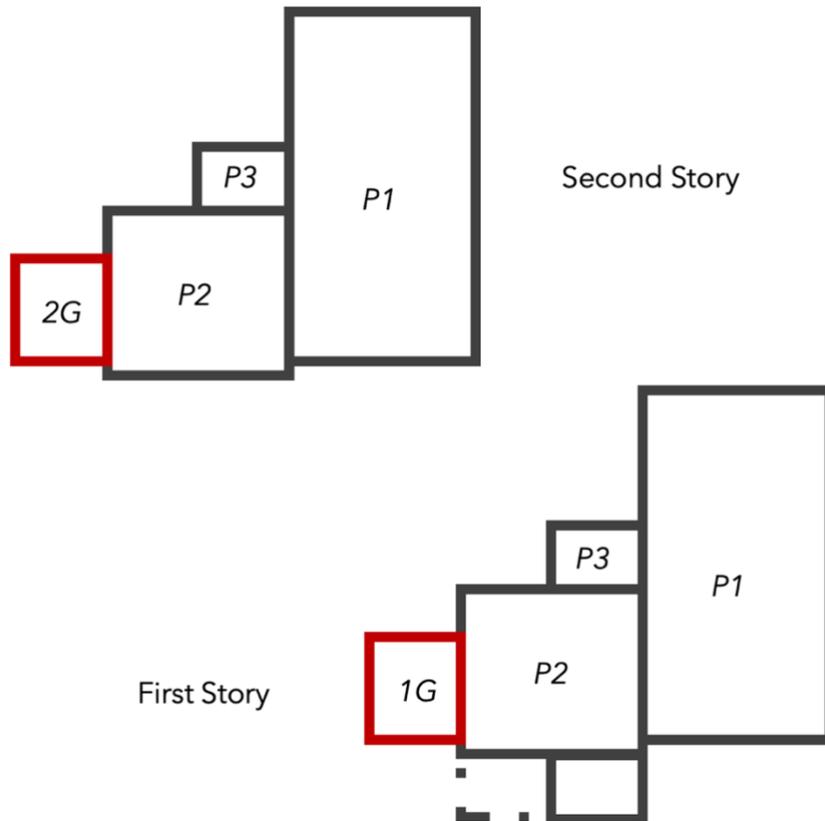
Figure 43. Phase IV house plan (*Grant Cunningham, 2022*).

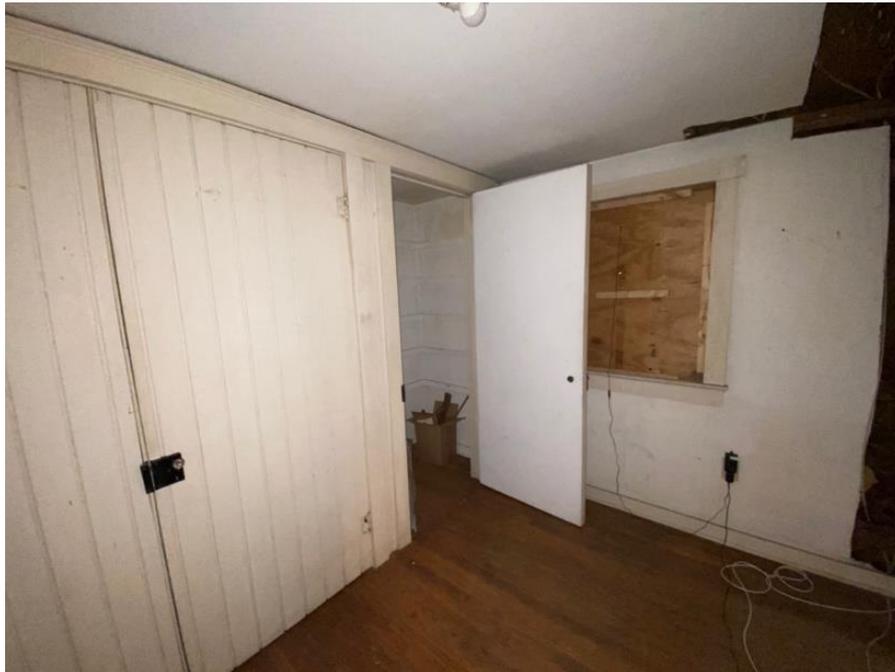
Figure 44. Second-story sewing room (Room 2G), west and north elevations, Phase IV 1967 addition (*Grant Cunningham, 2022*).

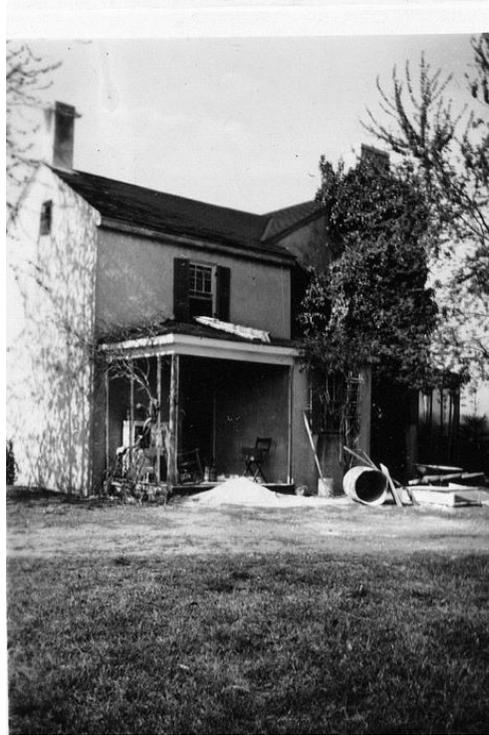
Figure 45. ca. 1942 photograph showing Phase II end chimney situated on interior, viewed from south (*Goshen Farm Preservation Society*).
