Title of Final Project: HISTORIC STRUCTURE INVESTIGATION:
THE GOSHEN FARM HOUSE, CAPE ST.
CLAIRE, MARYLAND

HISTORIC STRUCTURE INVESTIGATION: THE GOSHEN FARM HOUSE,
CAPE ST. CLAIRE, MARYLAND

Final Project submitted to the Faculty of the Graduate School of the
University of Maryland, College Park, in partial fulfillment
of the requirements for the degree of
Master of Historic
Preservation
2022

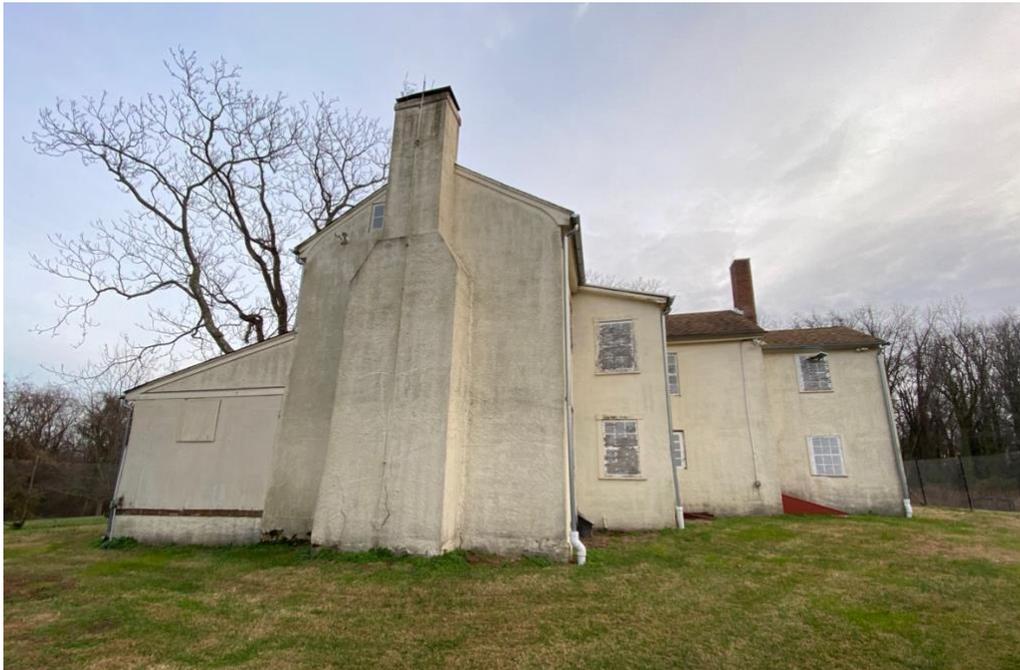
Figure 46. Goshen Farm House viewed from north, showing enclosed porch at left, stucco on all exterior elevations, and current building form with all phases visible (*Grant Cunningham, 2022*).

National Register. This is because the significance of the farmhouse under Criterion C requires the retention of the building's *historic integrity*, which is degraded by the presence of various non-historic elements on the exterior, namely the twentieth-century stucco cladding, enclosed front porch, and Phase III and IV additions. The National Park Service defines integrity as, "the authenticity of a property's historic identity, evidenced by the survival of physical characteristics that existed during the property's historic or prehistoric period," and recognizes seven elements that constitute integrity: location, setting, design, materials, workmanship, feeling, and association.⁹⁸ While the Phase I structure fulfills several of these elements (for example, it remains in its original location and setting, and has retained much of its original design, materials, and workmanship), alterations to the building's exterior have left it unable to visually communicate these qualities. The alterations also erase the more abstract elements of integrity at the site; for instance, the residence currently conveys the "feeling" of a twentieth-century farmhouse with a historic core, rather than an eighteenth-century farmhouse with peripheral additions.

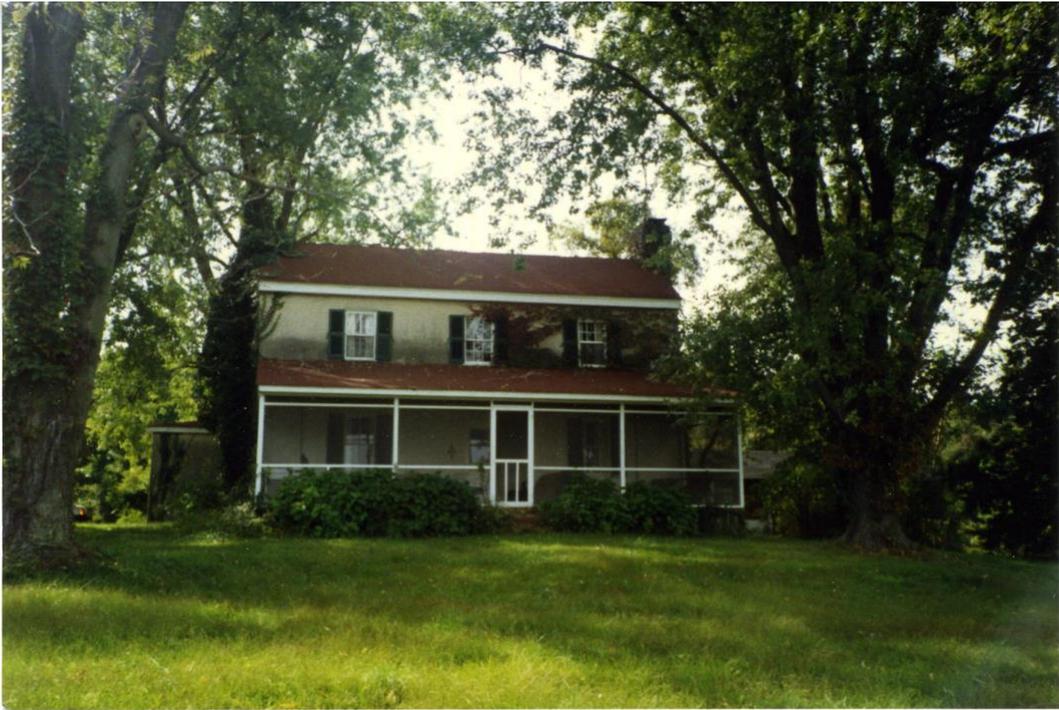
Figure 47. Façade of the Goshen Farm House in 1992, view from east (*Goshen Farm Preservation Society*).

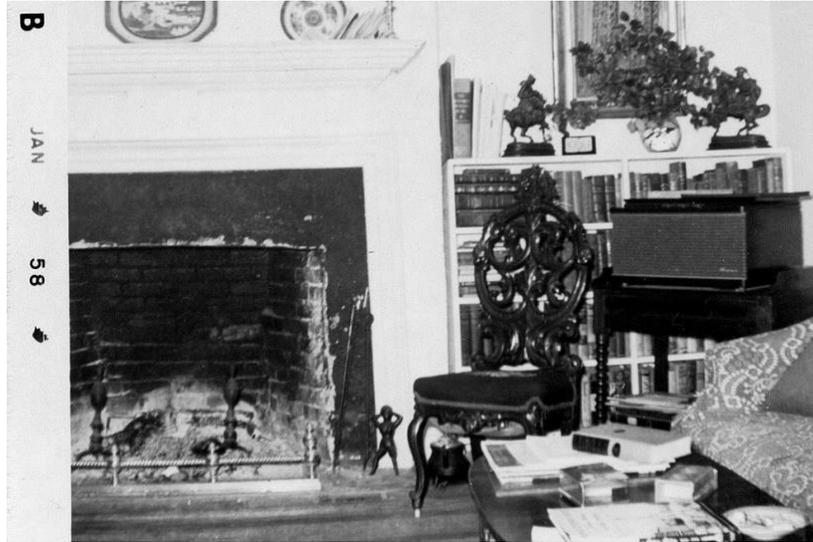
Figure 48. Room 1A (hall), north elevation, during Radoff period (*Goshen Farm Preservation Society*).

endeavor.¹⁰⁴ The paucity of Radoff-period material within the home would also necessitate extensive new construction to achieve the aesthetic goal such a vision requires (Figures 48, 49).

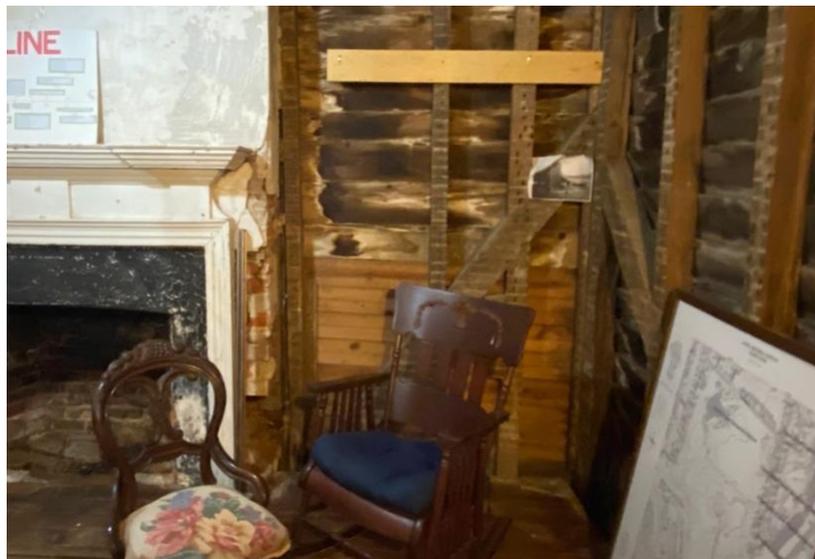
Figure 49. Room 1A (hall), north elevation, showing current conditions (*Grant Cunningham, 2022*).
