Title of Document: ENERGY ANALYSIS OF A METRO  
TRANSIT SYSTEM FOR  
SUSTAINABILITY AND EFFICIENCY  
IMPROVEMENT

ENERGY ANALYSIS OF A METRO TRANSIT SYSTEM FOR  
SUSTAINABILITY AND EFFICIENCY IMPROVEMENT

Thesis submitted to the Faculty of the Graduate School of the  
University of Maryland, College Park, in partial fulfillment  
of the requirements for the degree of  
Master of Science  
2023

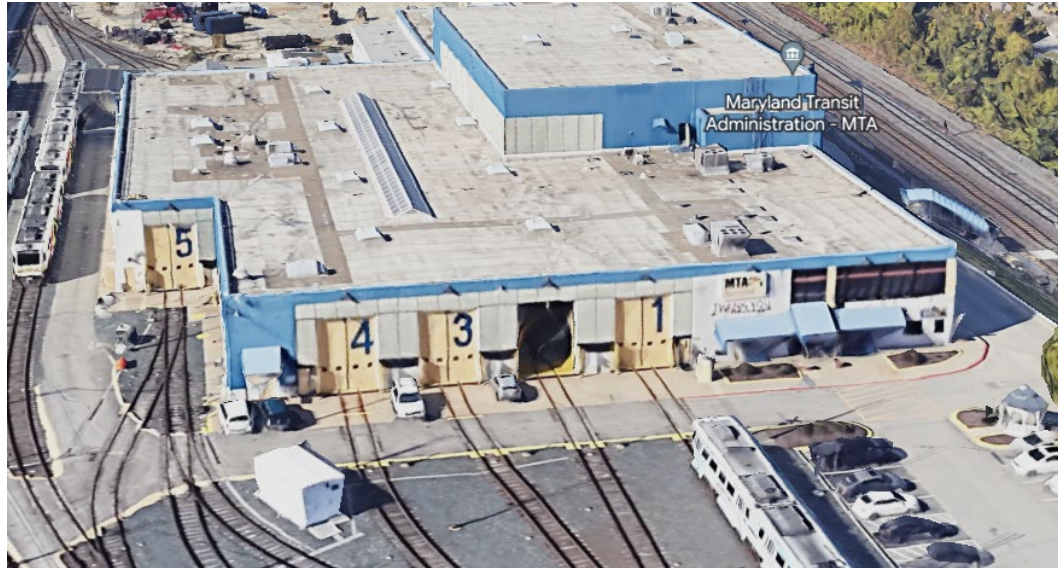
Figure 13: North Avenue overhead garage doors on the front of the facility.

The North Avenue Light Rail Maintenance Facility has 10 total overhead garage doors that are used to bring rail cars in and out of the maintenance facility. As shown in figure 13 below, there are five overhead garage doors on the front of the facility as well as five additional on the back of the facility as exits. These openings currently don't have any air curtains installed and could benefit from installation.

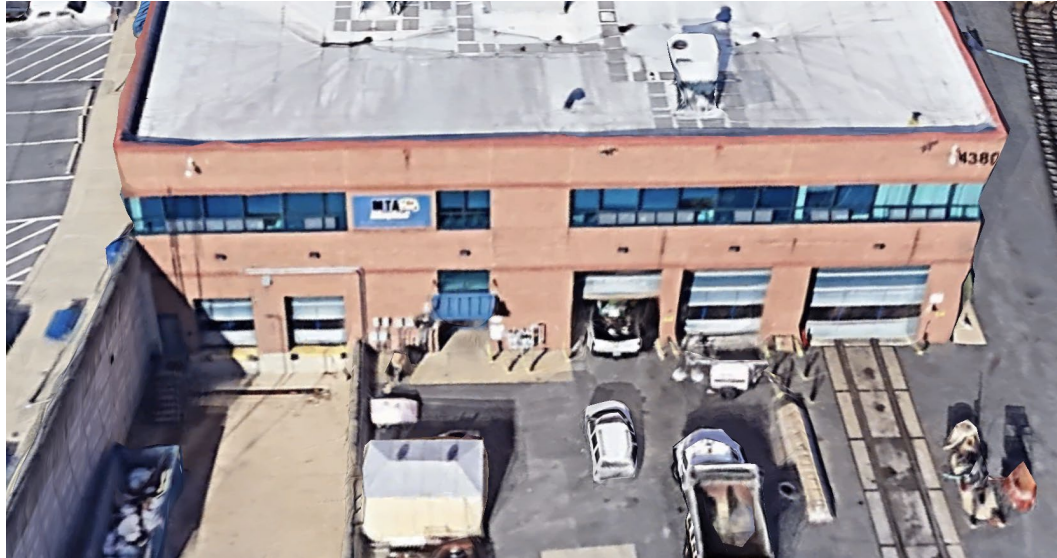
Figure 15: Overhead garage doors present at Old Court Facility

The Old Court Facility has a total of 5 overhead garage doors that are used for maintenance in the facility, shown in figure 15. There are no exit doors on the opposite side of the Old Court Facility and there are currently no air curtains installed in any of the 5 potential locations.

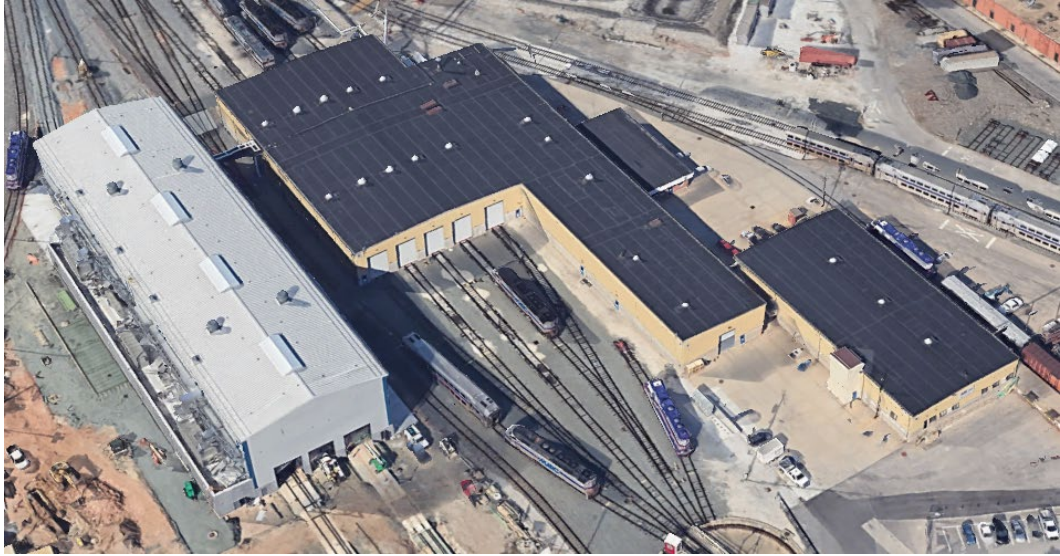
Figure 16: Overhead garage doors at the Riverside MARC Facility

Building 7 at the Riverside MARC Facility is strictly used for administrative purposes, which is the expected reason there are no garage doors in the exterior of the facility. Building 2 has 5 garage doors on the front with matching garage doors on the backside of the building, shown in figure 16. Buildings 3 and 4 each feature 3 garage doors spread along the exterior of the building. None of the garage door locations have air curtains installed in order to conserve energy.

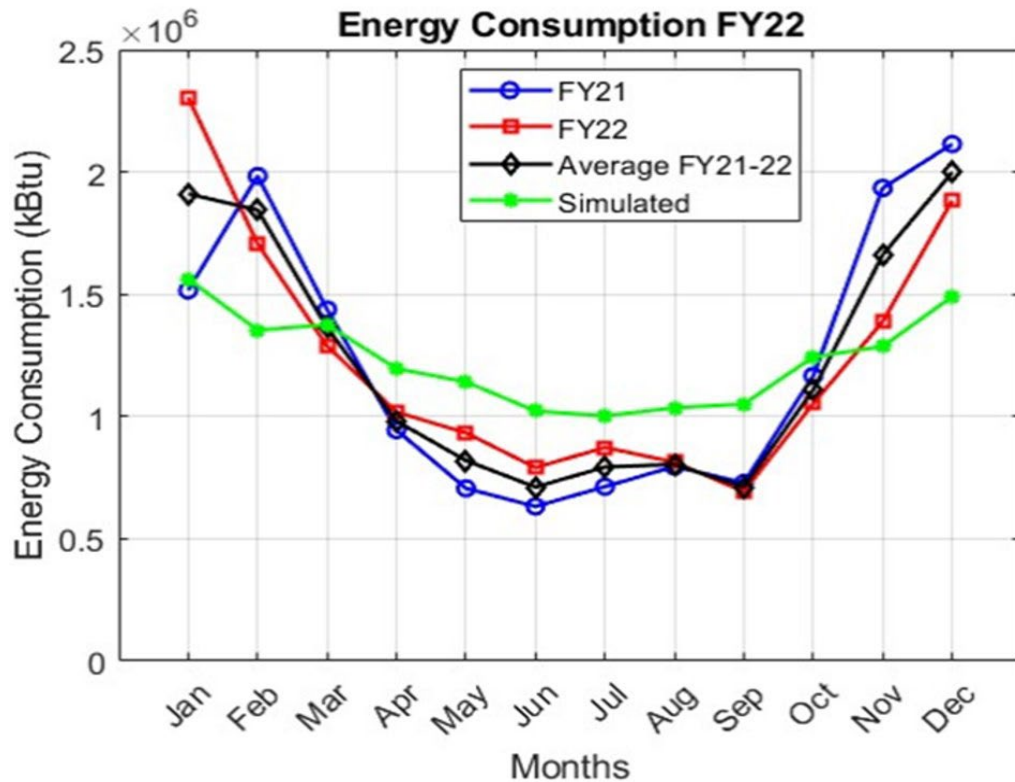
Figure 17: Simulated maintenance facility energy consumption compared to FY2021 and 2022.

Trace3D Plus offers a high level of customization, which suits the many different types of systems and zones found in the maintenance facility [49]. Additionally, the report generated for the simulation gives insight into the optimum sizing of the HVAC systems, indicating areas where energy needs are not being met and calculating net energy consumption for a fiscal year. The maintenance facility model was generated for the fiscal year 2022, during which data was actively collected and could be compared for accuracy. 2022 is also widely regarded as the “post-COVID” benchmark year [50], thereby giving insight into how the facility fared in its energy consumption pre-, during, and post-COVID-19. The model simulation obtained approximately the same energy usage of natural gas and electricity as the collected data. However, in the summer months, there was a slight overestimation of energy use, and in the winter months, an underestimation, as shown below in Figure 17.

Figure 17 shows the ability of the model to predict the baseline of the facility. It is important that an energy model emulates the facility’s performance so that this baseline model can be used to further analyze the building’s energy consumption and develop EEMs. To develop an energy model that replicates the energy performance of a facility, [51] found that the facility’s metered energy consumption values need to lie within the metered consumption of the year being simulated (2022), the preceding year (2021) and the average of the two years. Furthermore, ASHRAE Guideline 14-2014 prescribes no more than 15% and 10% deviation in monthly and annual data, respectively [52]. The maintenance facility energy model fell within these tolerance limits, hence validating the approach and the model's accuracy in replicating building energy performance. We thus concluded that simulated values were close enough to justify the model’s use for

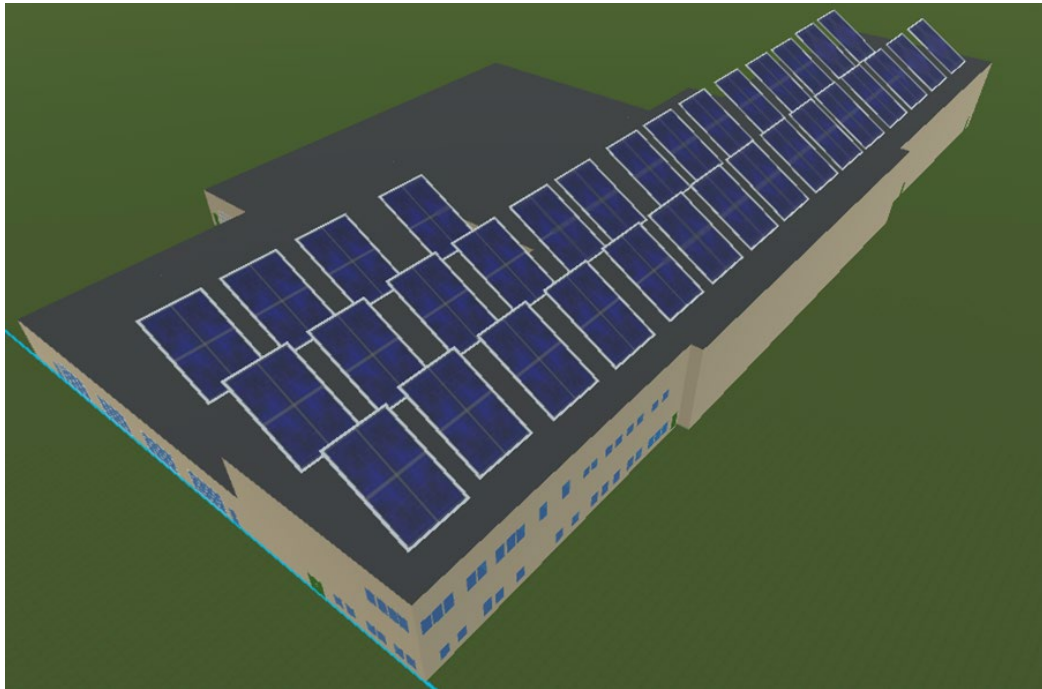
Figure 23: Model view of implemented Solar PV in Trace3D

This electricity savings accounts for around 33% of the facility's energy consumption in the base model. The solar panels did not have any energy storage capability in the simulation, so it was assumed that the energy that was produced directly supplemented the energy from utility sources. Installing energy storage equipment could
